### **I.L.S. Engineering Limited**

<b>Name</b>	<b><u>No 000 Wear Mode Explanation Example</u></b>
<b>Objective.</b>	OOOOOOOO, Check oil for Wear Metal Particles and any possible contamination, Information found used to establish machine condition and future maintenance requirements.
<b>Method.</b>	Sample of approx 100 mil received. Sample preparation in accordance with I.L.S. standard laboratory practices. One sample processed <b>1 mil in volume, therefore the amount seen in the video pictures is the actual debris filtered from 1 mil of oil.</b>

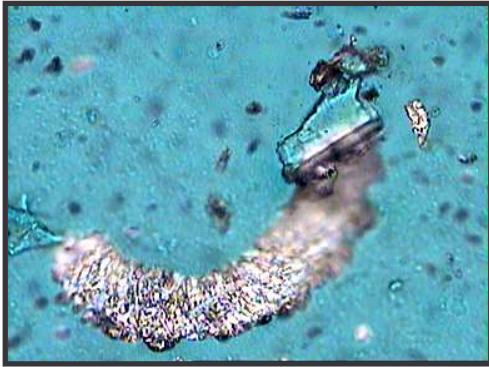
**Cutting Wear Particle  
80 Microns, @ 500X**

Cutting Wear Particles are caused by hard contamination, usually Silica (Sand) or hard contaminant being present in the machine.

Cutting Wear Particles are formed when the lubricating film has been penetrated, by the hard contaminant, gouging off the load bearing surfaces, producing the distinctive swarf shape from machined metal components.

These metal particles are carried by the oil flow through other load zones, snowballing the effect and further damaging load-bearing surfaces.

Damage will continue to this machine until the contamination is completely removed

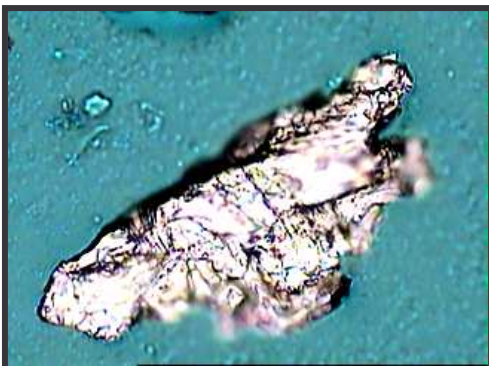
**2 Body Fatigue Wear Particle  
50 Microns, @ 500X**

2 Body Fatigue chunks occur when the machine's cyclic application of the stress, is in excess of the design value.

The machine has been overloaded, past the capabilities of the metals surface, creating a crack or dent. Repetitive bruising in this area fractures the metals sub-surface causing the area to eventually spall out. This creates the familiar deep pitting and scaring damage observed on load bearing surfaces.

These spalling metal particles are carried by the oil flow through other load zones, snowballing the effect and further damaging load-bearing surfaces.

Damage will continue to this machine until the contamination is completely removed

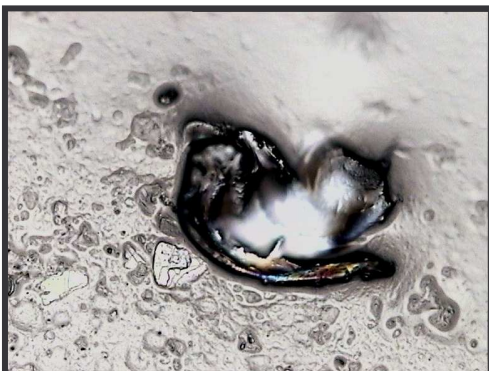
**Cutting Wear Generated by 2Body Fatigue  
60x50 Microns @100x**

Cutting Wear Larger then 2.5 microns in width and 30 microns in Length are generated by 2 body Fatigue Abrasive Wear, i.e. one surface penetrating another along with sliding or overheating wear particles.

Damage will continue to this machine until the contamination is completely removed

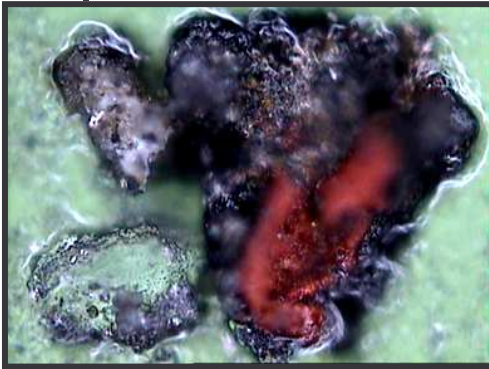
**Dark Metallo Oxide Particle  
60 Microns @ 500X**

Note fine pieces of metal imbedded in surface of particle.

Dark Metallo-Oxide and Black Oxide Particles are formed when machine is being over driven beyond the capability of the lubricant. The heat and pressure generated causes lubricant starvation. When Red Iron Oxide (rust), is forced through the load zone it Polymerises and forms Dark Metallo-Oxide and Black Oxide Particles. There are many forms of Iron Oxides  $FeO$ ,  $Fe_2O_3$  and  $Fe_3O_4$ . To rectify this wear mode the lubricant should be up graded to a product more suitable to the machines operating environment

Damage will continue to this machine until the contamination is completely removed

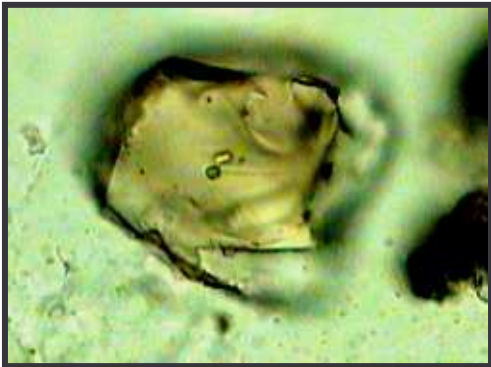
**Silica Crystal**  
**60 Microns @ 500**

This application is contaminated with silica crystals (Sand). The lubricant flow forces the Silica through the gears and bearings, easily penetrating the lubricating film, cutting the load bearing surfaces.

The entry of Silica must be prevented and the fitting of a Mainlube Breather/Bladder and water drain system will assist with water removal. Damage will continue to this machine until the contamination is completely removed

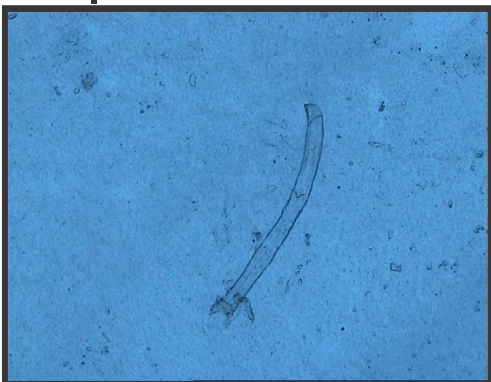
**Filter Fibre**  
**55 Microns @ 100X**

Fibres in used oils may be from Internal filter damage and/or textile matter ingress. The occurrence of the filter fibre material is an indicative of a filter failure. The fibres can clog filters and the flow path of bearings, resulting in bearing overheating and potential failure.

Damage will continue to this machine until the contamination is completely removed
